A SUCCESSFUL STRATEGY FOR MANAGING THE MECHANICAL INTEGRITY OF COKE DRUMS

ABSTRACT

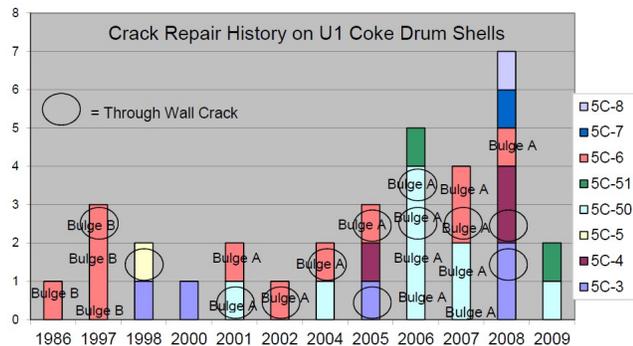
Figure 1 is a bar chart that tracks the number and location of shell cracks in the eight drums of U1. The abscissa is the year and the ordinate is the number of cracks. The data is color-coded per drum number and through-wall cracks are identified using circles.

The chart shows that first and most recurring cracks were found in drum 5C-6. First shell crack in the unit was recorded in 1986 in the 5C-6 area later identified as “Bulge B”. In 1997, three cracks were found in the same bulge including a through-wall crack. Starting in 2001, another relatively small local bulge in the same drum, referred to as “Bulge A”, became the most problematic bulge and site of recurring through-wall cracks on a near annual basis. This small bulge which was insignificant in size and far from circumferential seam welds became a real challenge and a cause of concern regarding the ability to predict and reliability of repairing failures.

Starting twelve years after the first crack was found, since 1998, all drums have cracked and cracks were found almost on an annual basis. In addition to 5C-6, through-wall cracks were found in drums 5C-3, 5C-4, 5C-5, and 5C-50 (the younger chrome alloy drum). In some cases, steam spewed from cracks and, in one case, a flame shot from the drum to a distance of about 30 ft (9,144 mm).

The chart shows how crack numbers grew almost exponentially which is common in industry. However, this trend came to an abrupt change after 2008, the year the new mechanical integrity management approach was first implemented. The last through wall crack was found in 2008 and, in 2009, two cracks that did not go through wall were found in 5C-50 and 5C-51. Since then, this data update has been discontinued because there were no more unpredicted cracks in these drums. The chart stops at 2009 because cracks after this year were predicted by the new inspection-assessment routine.

Figure 1: Crack Repair History in U1

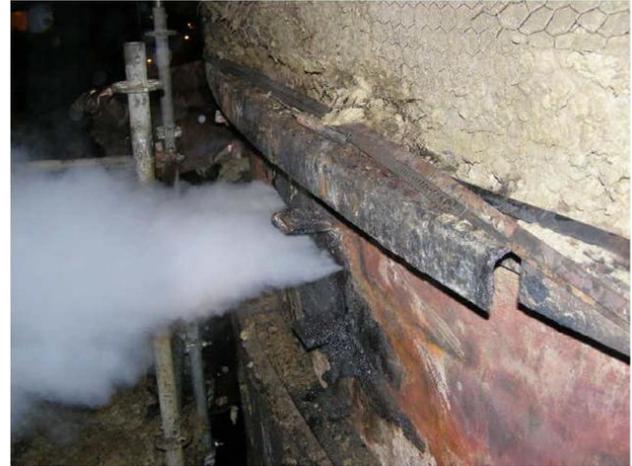
Figures 2, 3, and 4 show examples of a leak found during quench, a through-wall crack at a bulge, and “elephant-skin” cracking in the drums, respectively.

Figure 2: A leak found during quench

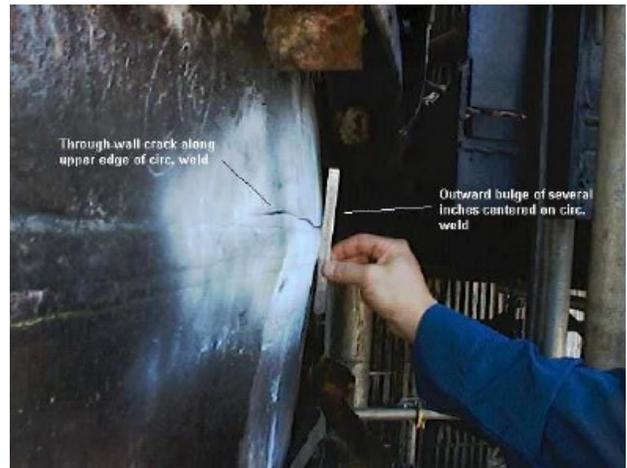
Figure 3: Typical bulge and through wall crack

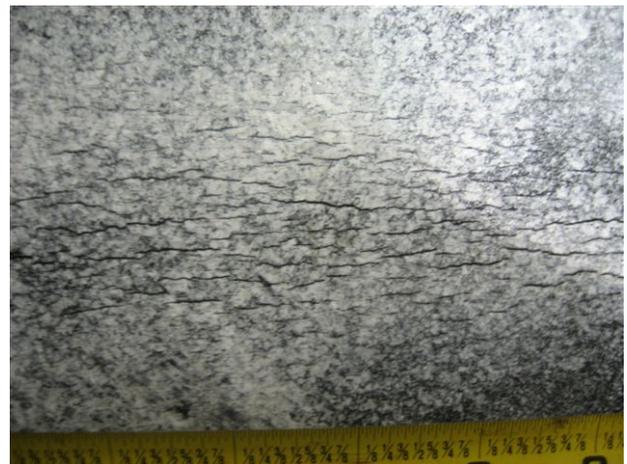
Figure 4: Typical Elephant skin cracks

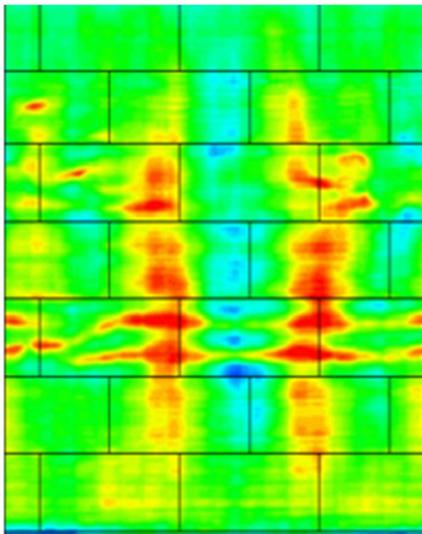
The extent and methods of inspections are a function of bulging severity and inspection history for each drum. Visual as well as nondestructive testing methods have been employed to search for and size cracks. But the core and only global inspection method consistently utilized is internal laser scanning which provides the radius measurements that are needed to perform bulging assessment. An example color-coded radius map from an internal laser scan is shown in Figure 5.

Figure 5: An example of a color-coded radius map from an internal laser scan

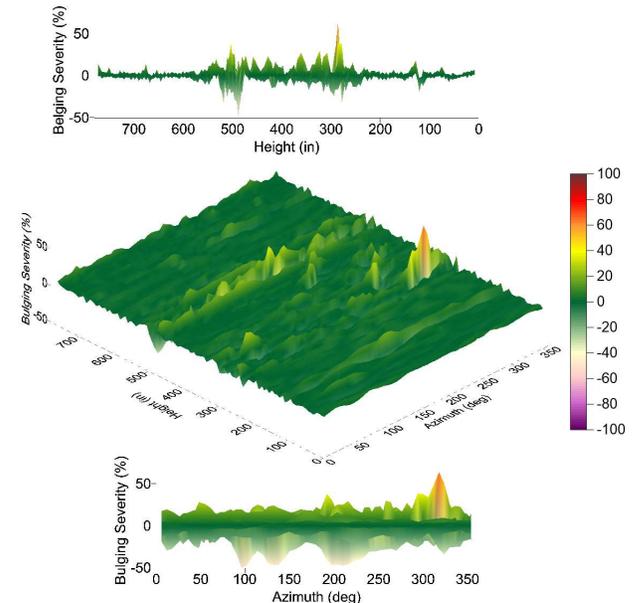
In 2011, a method that uses plastic strain as an indicator of bulging severity was developed. [4] The analysis provides a measure of severity from the ratio of calculated plastic strain to strain limit in a percentage form. To help identify and visualize locations that are susceptible to bulging-induced cracks, three-dimensional severity maps can be presented of this measure. The map of Figure 6, which was calculated from a laser scan of drum 5C-6, shows a sharp red peak that corresponds to “Bulge A” which had experienced repeated cracks over the years as well as a mild circumferential severity zone (yellow to light green) that corresponds to the stable “Bulge B”. In the three-dimensional map, the x-axis is azimuth around the circumference in degrees; y-axis is the height in inches from the bottom Tangent Line; and Z-axis is bulging severity as a percentage.

Figure 6: An example bulging severity map

Severity grade is defined as “Design”, “Concern”, “Danger”, and “Failure” levels. Positive and negative values refer to failure initiation on the inside and outside surfaces of the wall, respectively. Table 1 relates this strain-based bulging severity measure to severity grade, likelihood of bulging-induced cracks, and recommended frequency of laser scanning.

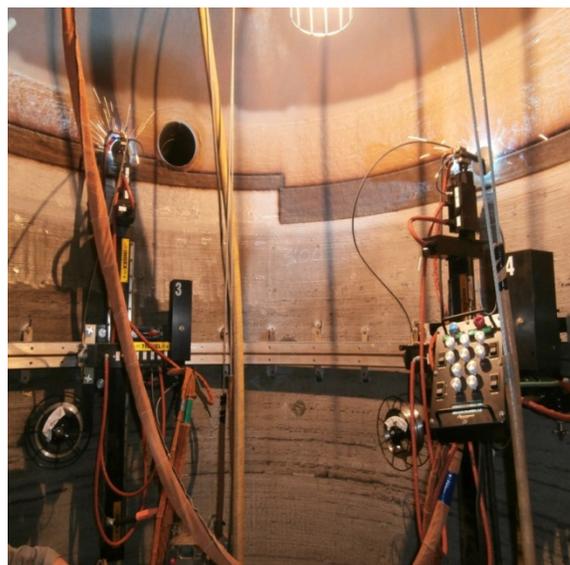
Weld overlay repairs are performed using automated welding technology, as shown in Figure 7. The computer controlled welding that is supervised by qualified operators has been utilized for structural repairs of coke drums for about 20 years. A recent comprehensive long-term repair of a set of eight drums at one site totaled more than 3,000 square feet (280 m²) of weld overlay area. [7]

Figure 7: Automated weld overlay in progress

In 2008, the first large band of weld overlay repair was done on drum 5C-6. Since then, all 8 drums of the U1 coker plant have been overlaid with welding bands.

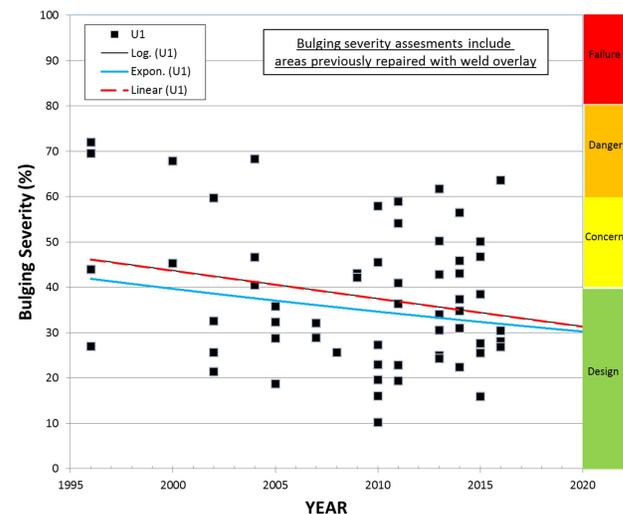
First, bulging severity did not only stabilize but also decreased. This means the bulges have actually straightened up and became less severe. So, while the initial purpose of weld overlay repairs was to stop bulging deterioration and extend fatigue life, reductions in bulging severity has come about as a side effect of residual stresses that were created by the welding process. Figure 8 shows the collective bulging severity trend of all the U1 drums together. It shows a downward trend indicating that drums bulging have collectively improved. This improvement is dramatic and unique in the coker industry. The consequence of the improvement is a longer predicted economic life of the drums and a reduced need for inspections.

Figure 8: Bulging severity trend of U1 drums

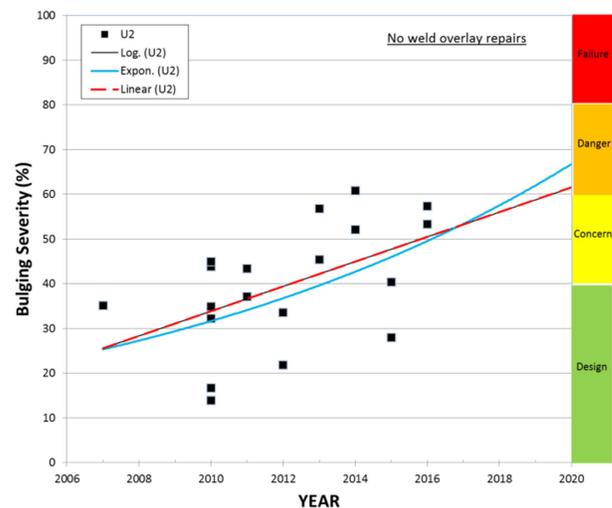
Bulging severity trend of U2 drums is shown in Figure 9. These drums, which did not use the same mechanical integrity strategy, show a significant increase in the severity of bulging damage over time.

A comparison with the U1 chart of Figure 8 indicates that the new integrity management process has resulted in a drastically different performance that will likely lead to longer economic life and a reduced inspection effort for the drums.

Figure 9: Bulging severity trend of U2 drums

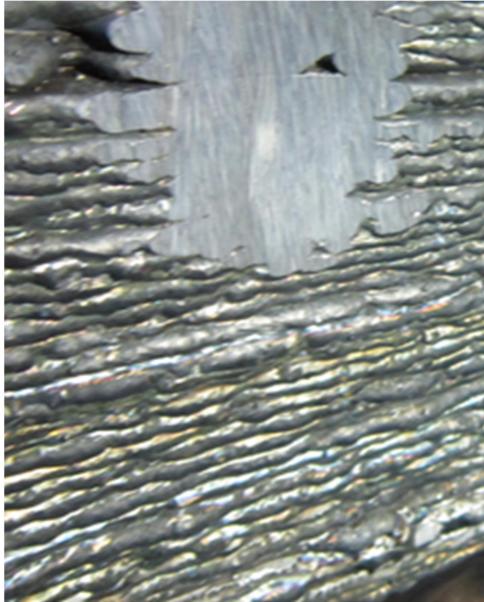
company. An example of a poor surface finish is shown in Figure 10.

Figure 10: An example of a poor field weld surface with sharp grooves

One possible way to address this concern is to require grinding weld overlays smooth, but this can be very costly and time consuming especially for large-scale repairs. Therefore, in order for these repairs to realize their full potential, operating companies must have the ability to ensure a minimum level of quality for weld overlay surfaces in a field work environment which can only be accomplished by the ability to: (a) measure field surface roughness in a practical and timely manner, (b) determine the acceptability of a measured roughness using a performance-based criterion, and (c) repair areas that fail the criterion before the repair job is complete. Effort is underway to develop the tools needed to accomplish this goal.
