PVP2018- 84736

PERFORMANCE OF BULGES AFTER WELD-OVERLAY REPAIRS

Mahmod Samman

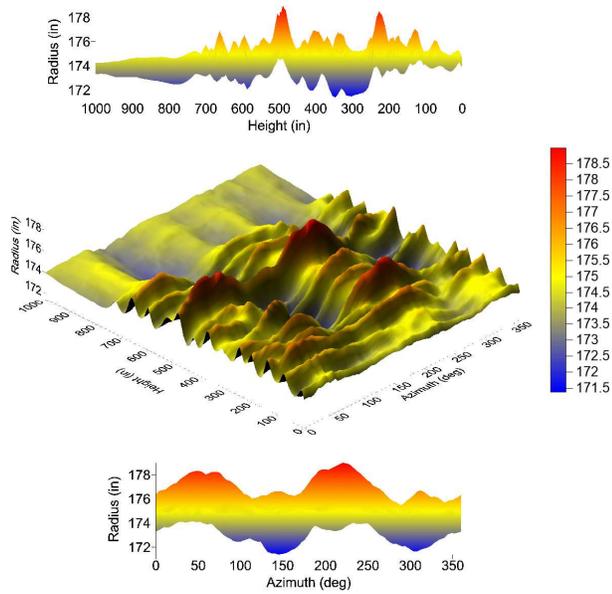
Fig. 1 A Representative Bulging Pattern

A representative bulging pattern in these drums is shown using the three-dimensional radius map and side views in Figure 1. Using the bulge classification of [21], the map shows a relatively mild “uniform growth” below fill level, one or two “band growth” areas, and numerous “local bulges”.

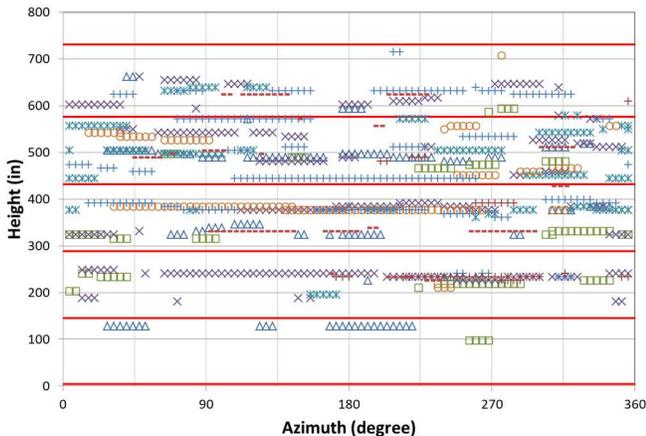
Fig. 2 A Chart of Severe Bulge Indications (each symbol represents one drum)

The severity of bulges in these drums was assessed using the plastic strain method of [7-9] and [19-20]. Indications that exceeded the “Design” level in all drums are shown in Figure 2. In the chart, a unique symbol is used for each one of the eight drums. Azimuth is referenced to North, height is referenced to the bottom tangent line. Circumferential seam welds which are commonly associated with shell cracks are indicated using red lines.

As the figure shows, most indications are located in middle shell courses (third and fourth from the bottom) followed by the second and fifth courses and then by the first. No indications were found above the fill level which varies at a height of approximately 787 inches (20 m). This general bulging pattern is in-line with industry experience, as reported in [22]. However, bulges in these

drums were located both at and away from circumferential seam welds not only at these welds as many operators have reported in the past. This is likely due to the high fabrication standards that were used for making welds in these drums.

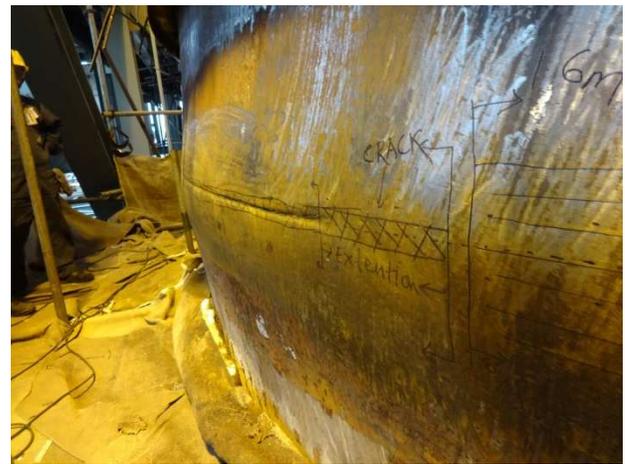
Fig. 3 Example of a Bulge-Induced Crack

Shortly after placing the subject set of drums in service, some of them started experiencing bulging and cracking in an unpredictable manner. After approximately ten years of service, the first through-wall crack was observed. An example of a bulge-induced crack is shown in Fig. 3.

Repairing bulging-induced cracks by gouging them out and rewelding is a short-lived solution. To extend the economic life of these drums and minimize unplanned shutdowns, bulging was managed in a proactive manner using a three-pronged process:

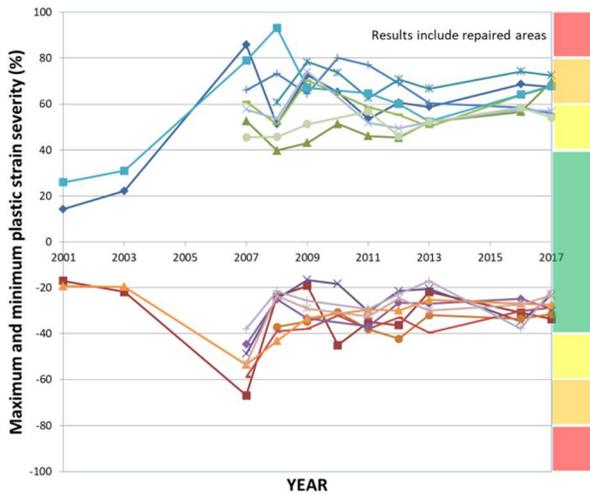
Fig. 5 History of Plastic Strain Severity in Drums

The history of plastic strain severity in these drums is shown in Figure 5. Maximum and minimum values in the chart represent the range of severity for all bulges in

all drums including bulges that were repaired using weld overlay. The colors on the side of the chart indicate bulging severity that range from green (low) to red (high). The chart shows that after a history of successive increases in the magnitude of plastic strains, some drums demonstrated a decrease or a stabilization of severity.

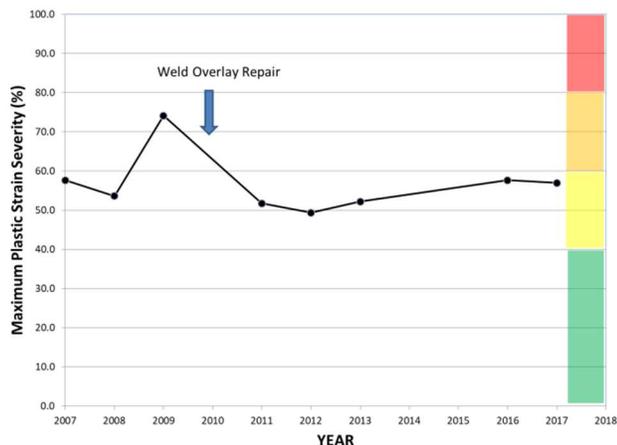
Fig. 6 Severity History of a Representative Bulge after Weld Overlay Repair

Above data describes performance of entire drums with all their bulges. The performance of individual bulges that receive weld overlay repairs is illustrated using the history of the example in Figure 6. This representative post-weld overlay repair performance in these drums is established using three scans prior and five scans after the repair was implemented. Like most such repairs in this set of drums, severity slightly decreased immediately following repairs and then stabilized or experienced a slight increase over the subsequent few years.

While the main goal of weld overlay repairs is to stabilize bulges that suffer from high plastic strains, the observed initial decrease in severity is caused by residual stresses that result from the welding process. This

favorable effect of weld metal solidification that results from welding on one side of a bulge in a cylindrical shell was confirmed using finite element simulation of the welding process. The subsequent mild increase of plastic strain over time is likely due to the partial gradual relaxation of these residual stresses under high thermal and mechanical loads generated by operation.
