COKE DRUM FORUM 2020
March 10-11, 2020, Houston, TX, USA

A COKE DRUM SKIRT REPLACEMENT – ANALYSIS & PRACTICAL CONSIDERATIONS

Alex Berry & Antonio Seijas
Phillips66

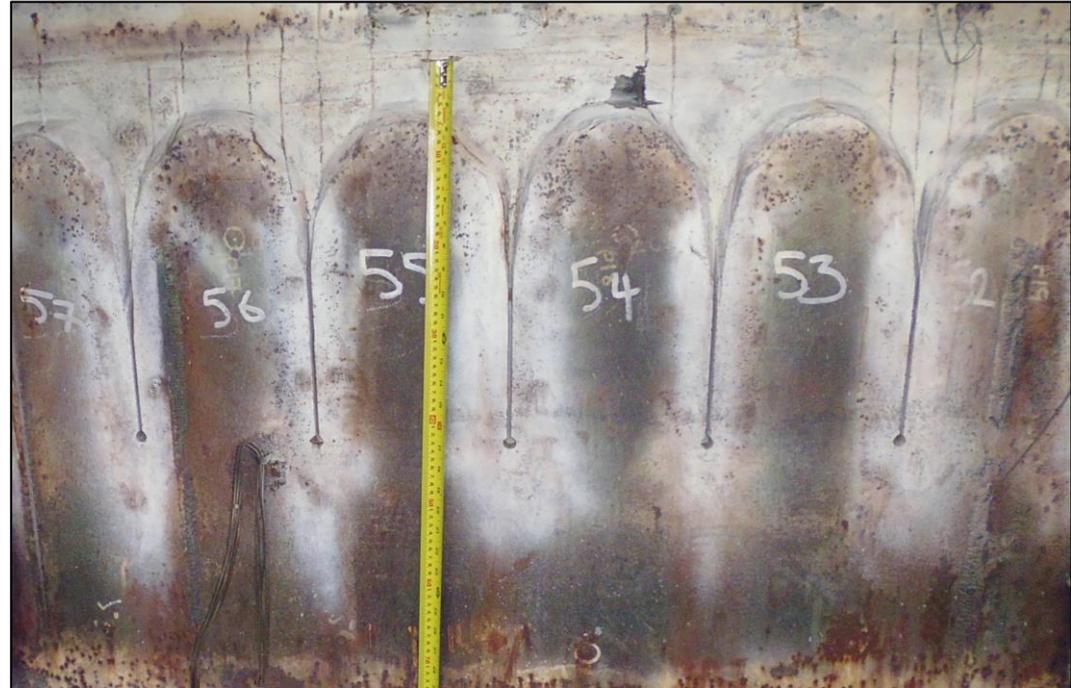
Drum specification

- Service: Premium Coke drums
- Built: 1975
- Material: ASTM A387 Gr C (1-1/4 Cr), 52mm thick with internal 405 cladding
- ID: 21'-0", T-T: 71'-5"
- Skirt design: tangential (scalloped)
- Skirt thickness: 23mm
- Mass (unfilled): 260 Tonnes

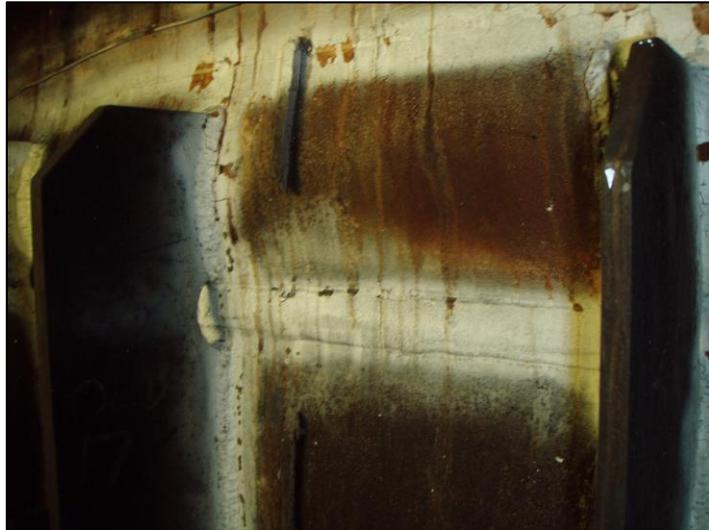
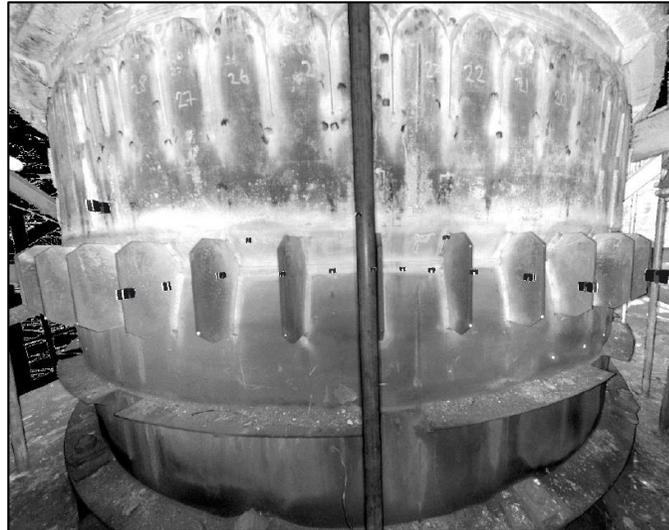
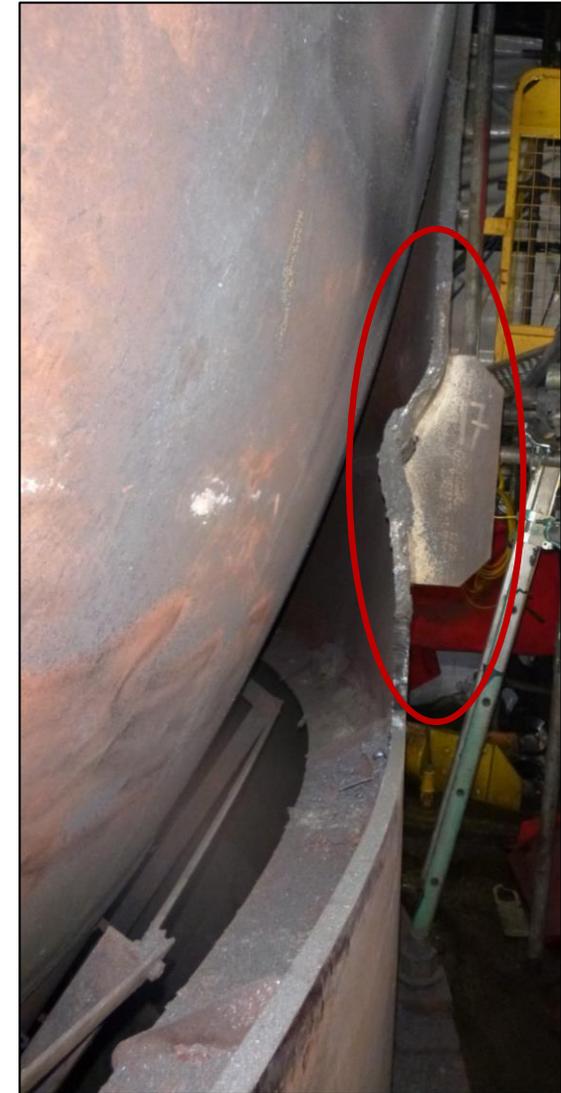
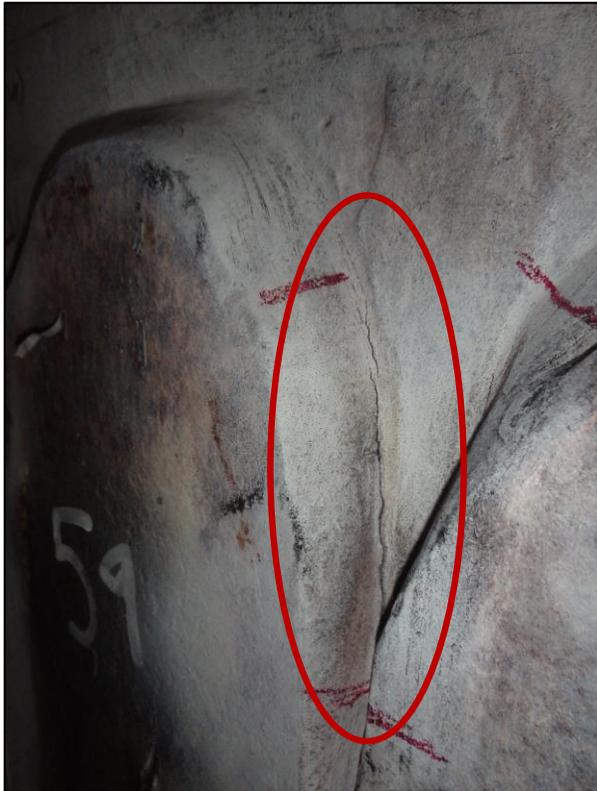
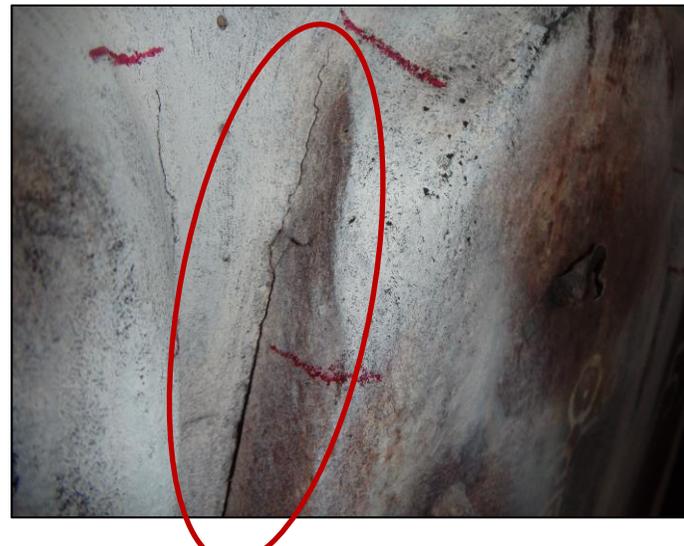
Skirt Bulges

- Severe buckling of skirt at Carbon steel to Chrome location.
- Arrested in 2006 after installation of support gussets.
- Bulges monitored through periodic laser scanning.
- Minor cracking at the gusset welds were observed during inspection windows and ground out each time.

Cone Cracking

- Original skirt design was a 'J' Prep scallop attachment.
- Extensive cracking on skirt and into cone section was monitored for many years with Advanced UT (slow growth rate).
- Maximum excavation depth during the repair was ~15mm which verified the UT results.
- Numerous on-going crack excavations to scallop area became unmanageable.
- Trigger for skirt replacement was a combination of the cracking and bulging particularly an inability to repair cracking behind scallops.

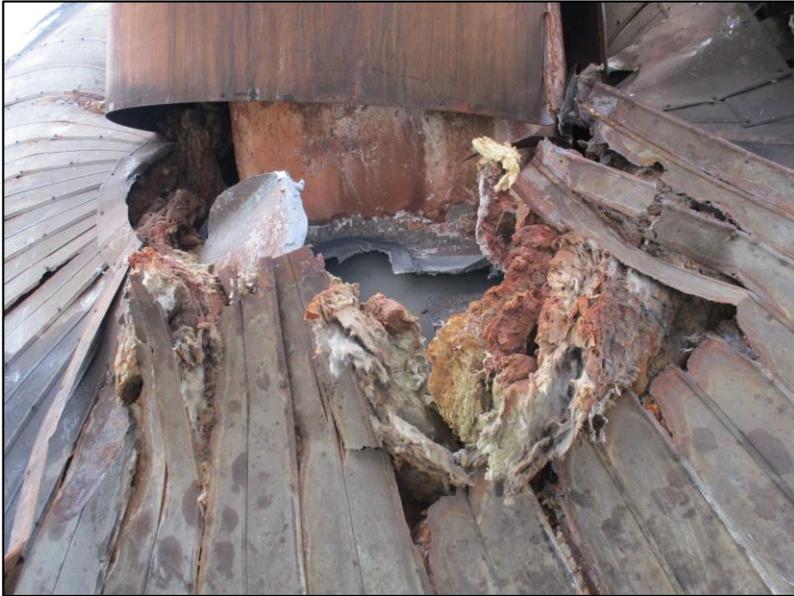
- Risk of brittle fracture due to cone cracking was considered when the first three segments are removed.
- An infinitely long crack, 8.5 mm deep could be tolerated (API 579 assessment criteria). Our cracks were known to be deeper (although shorter).
- To protect against risk of brittle fracture, all grinding, gouging and welding operations were performed at temperatures above 10°C (50°F)
- This wasn't onerous as these activities require a pre-heat as a requirement of the WPS & PQR.

Although unlikely, the risk of brittle fracture is very real. See picture (top left) which shows a brittle fracture on a coke drum top nozzle during lifting.

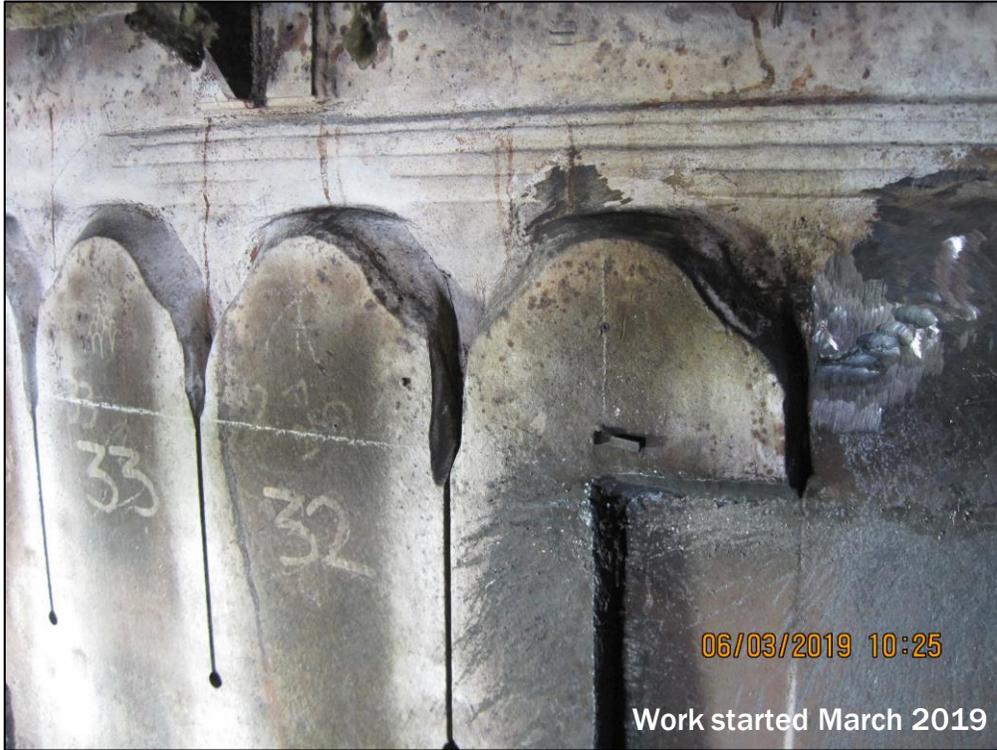
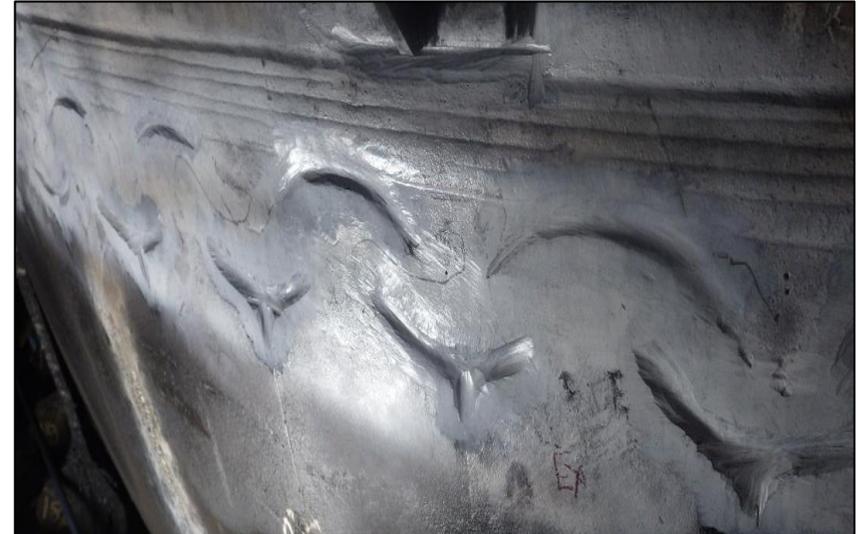
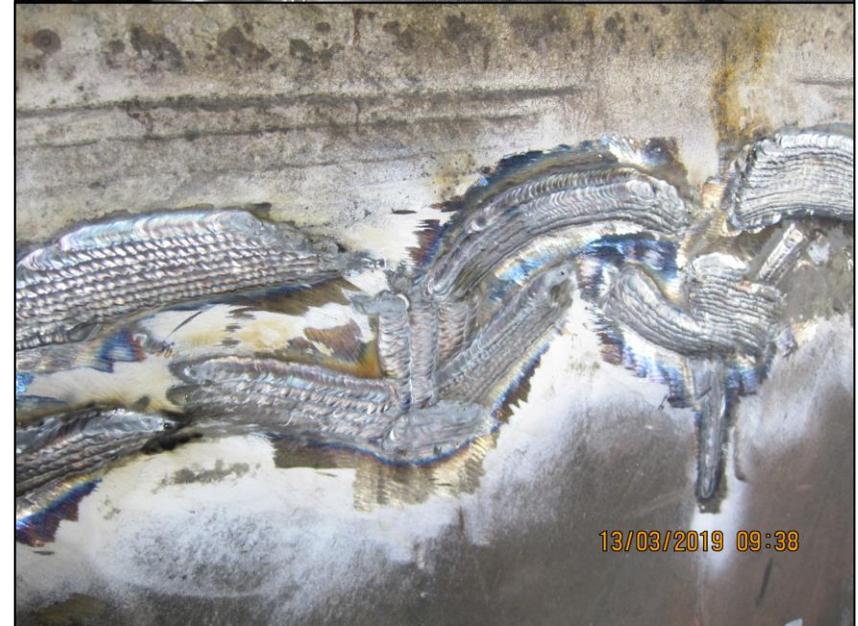
REPAIR SEQUENCE - CONE REPAIRS

1. 12(off) new skirt sections fabricated off-site.
2. Resistance heat pads installed on the inside of the drum.
3. Air-arc gouge existing skirt “window” sections (3 per drum). Pre-heat: 50 °C (120 °F).
4. Grind / gouge existing cone cracks verified with MPI. Pre-heat reduced to 40 °C (100 °F).
5. TIG (GTAW) weld repair excavations. Pre-heat to 150 °C (300 °F).

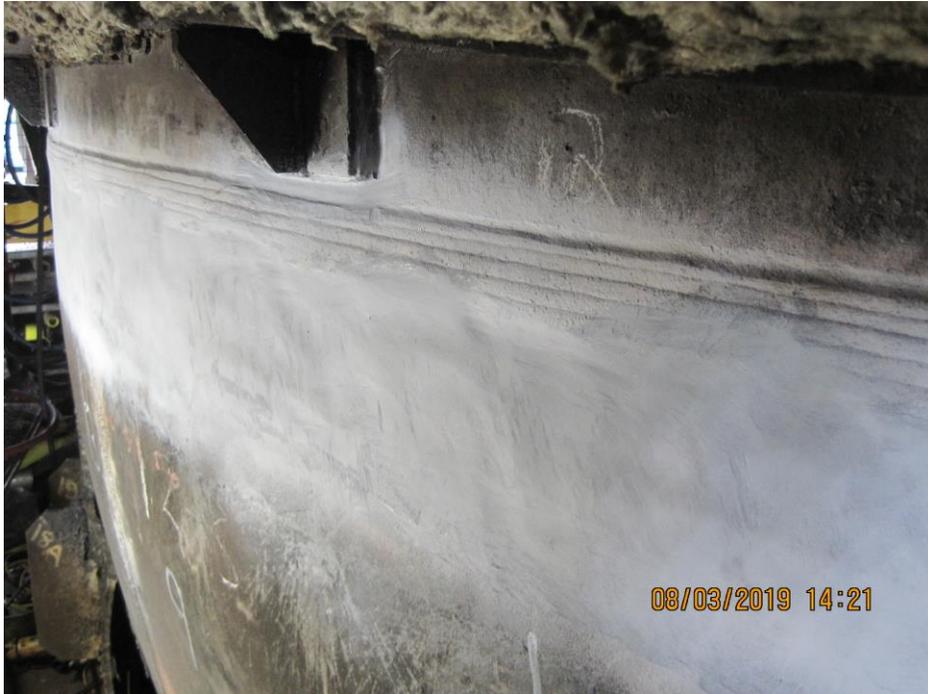
REPAIR SEQUENCE - SKIRT PREP

6. Grind flush and repeat MPI.
7. Mark up bottom skirt cut line (Note: this will set the location of the skirt-to-cone attachment weld*). Cut line is referenced from the concrete octagon.
8. Automated Oxy-Acetylene used to cut bottom skirt at 15° prep angle.

* Due to the skirt buckling the cone circumferential weld was out (vertically) by 1" over the diameter on one of the drums.

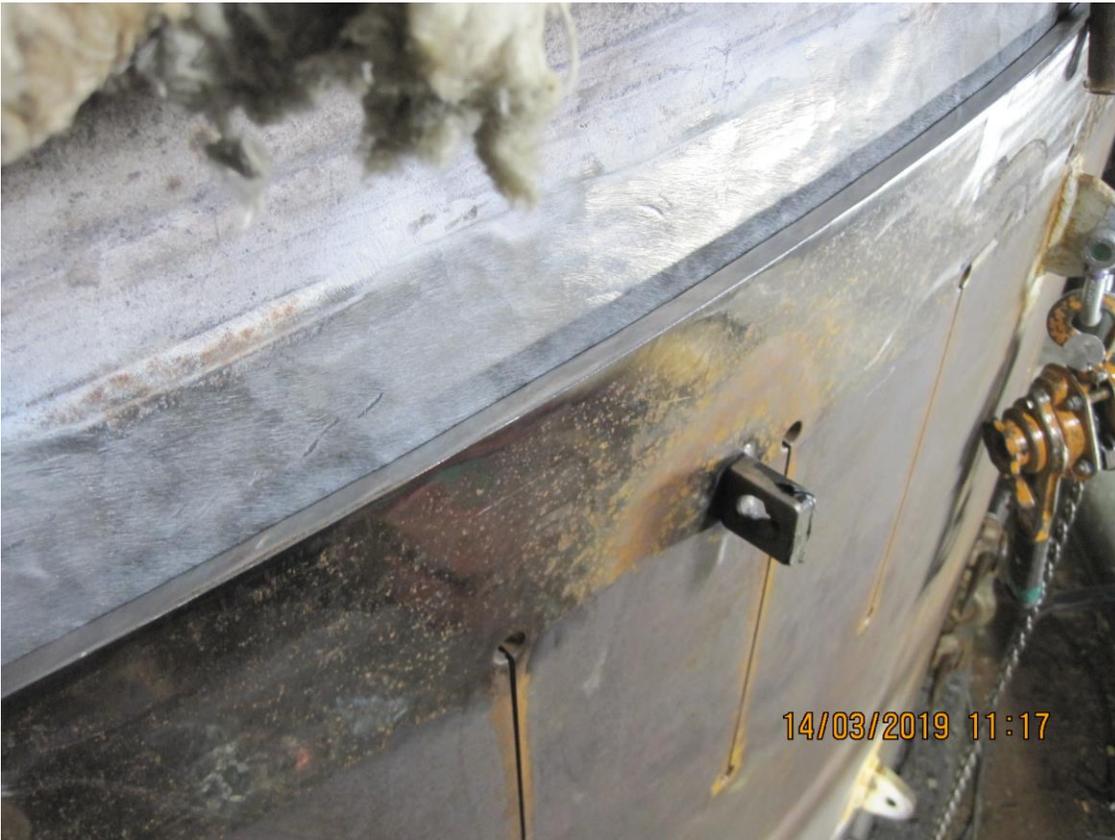
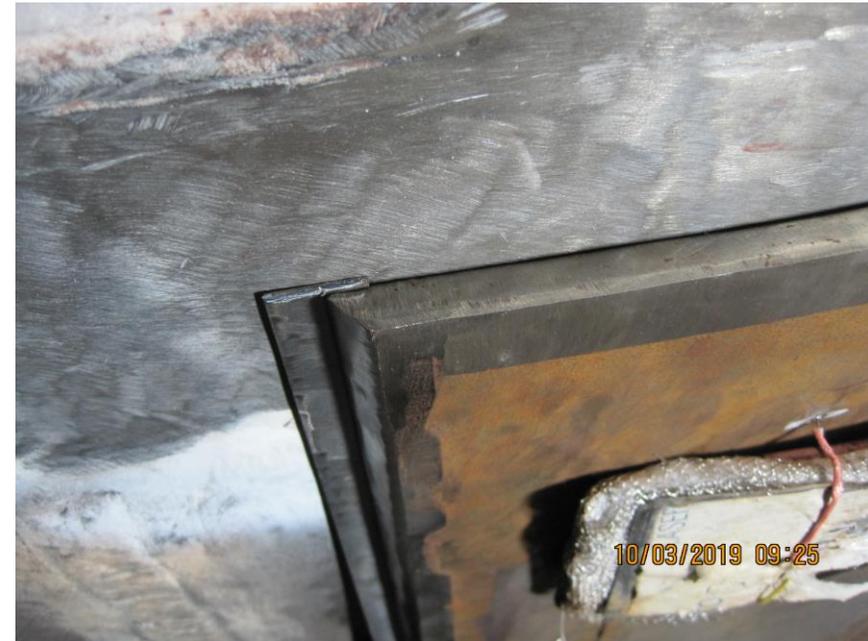
REPAIR SEQUENCE - SKIRT FIT UP

9. Install replacement skirt sections with backing strip, tack welding and “dogging” in the skirt as needed to achieve acceptable fit-up; 3 mm (1/8”) or less. Due to the skirt only being 19 mm (3/4”) thick, this was achievable in conjunction with the cone being reasonably round resulting in an average gap of 1.6 mm (1/16”).

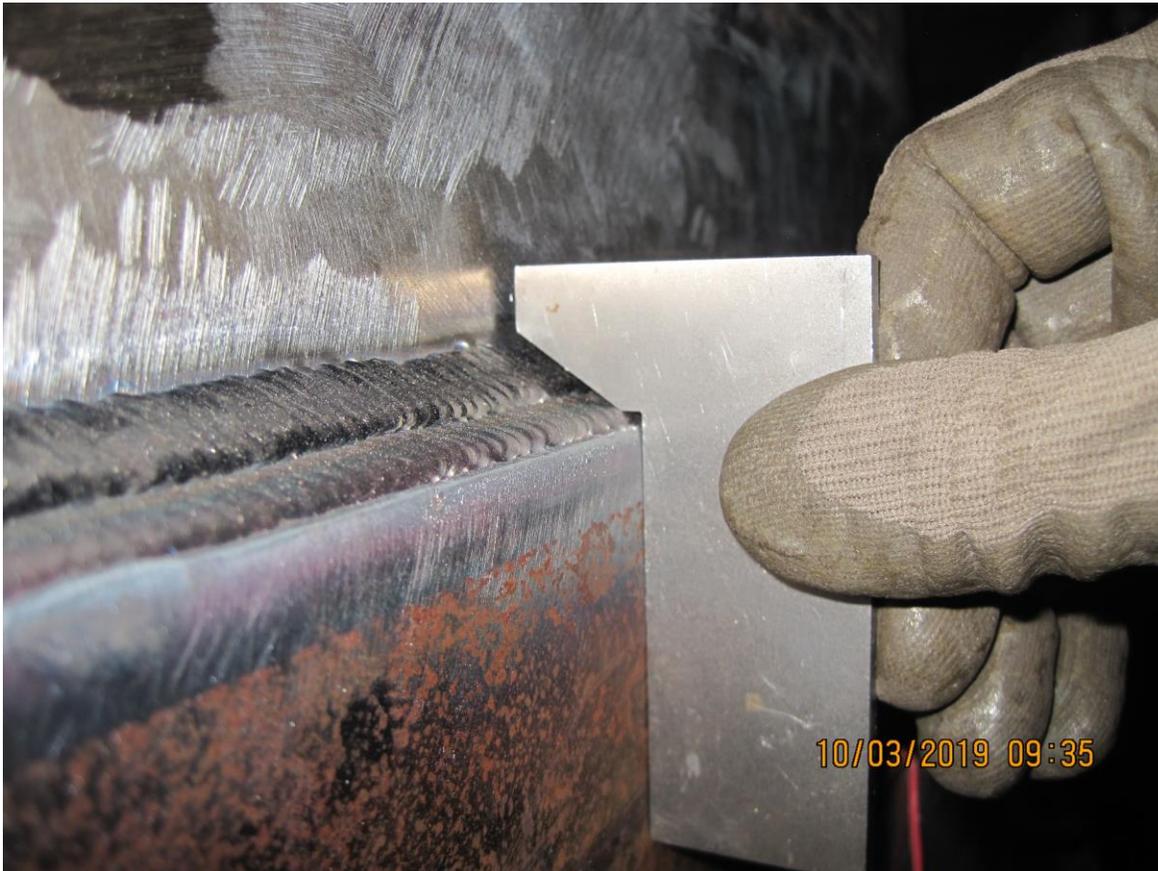
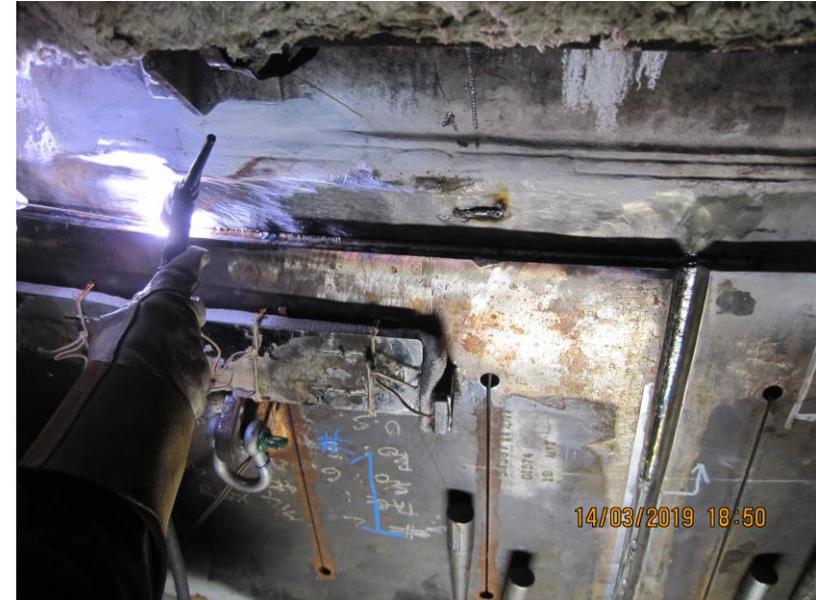
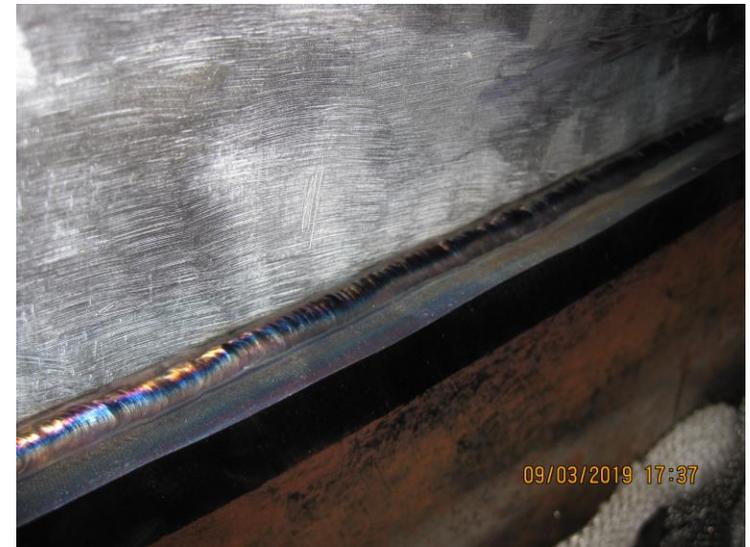
REPAIR SEQUENCE - TIG WELD

10. TIG (GTAW) attachment weld to a height of 15mm (check with gauge). MPI and PAUT (external) after reducing pre-heat.

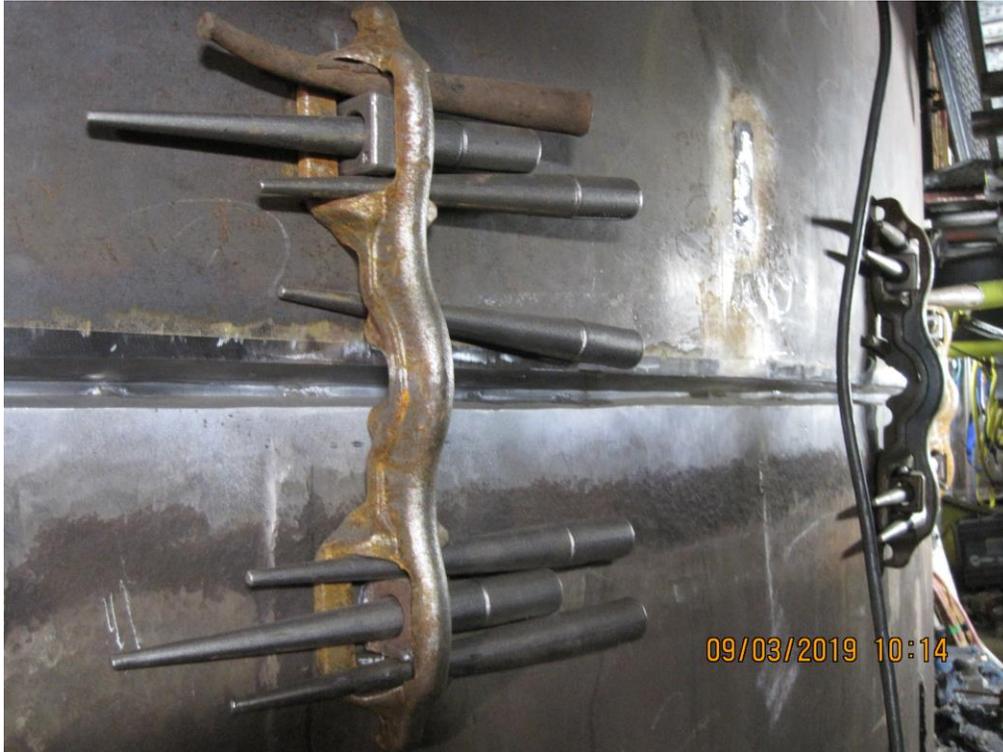
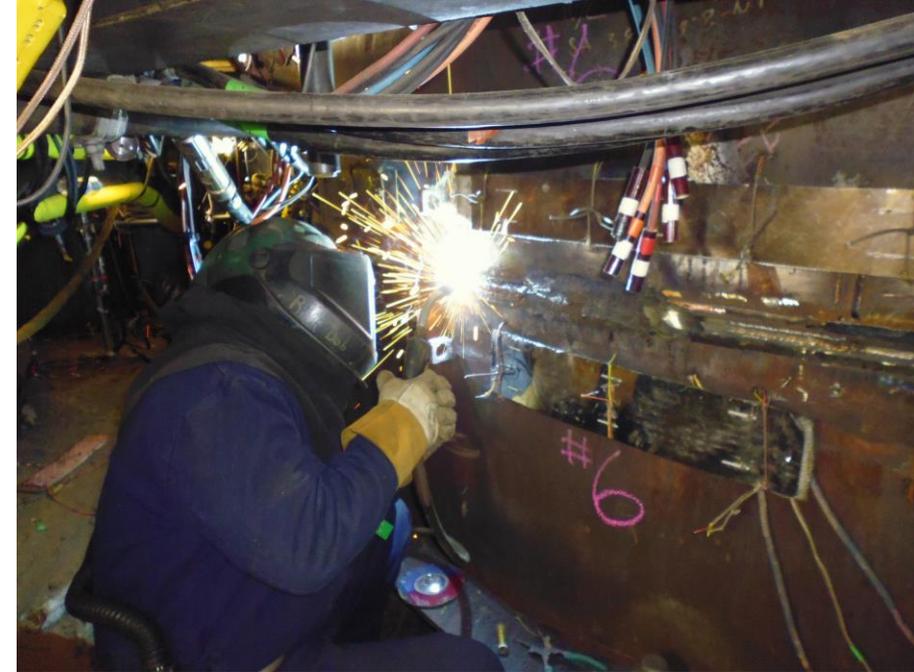
REPAIR SEQUENCE – DISSIMILAR WELD

11. Temper-bead MIG (GMAW) skirt-to-skirt dissimilar weld. Pre-heat to 150 °C (300 °F).

12. Air-arc gouge remaining skirt window sections. Note: Drum is now sitting on a 15mm weld over half its circumference!

13. Install remaining new skirt sections in the same way as the first sections.

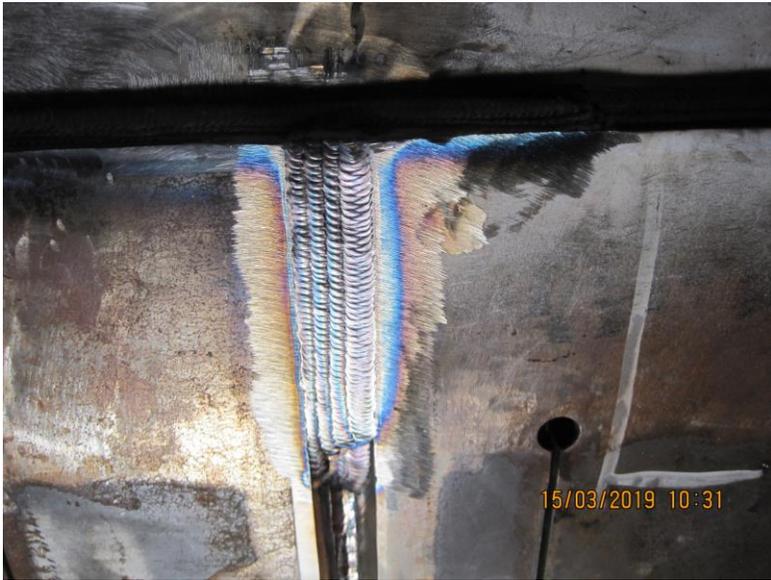
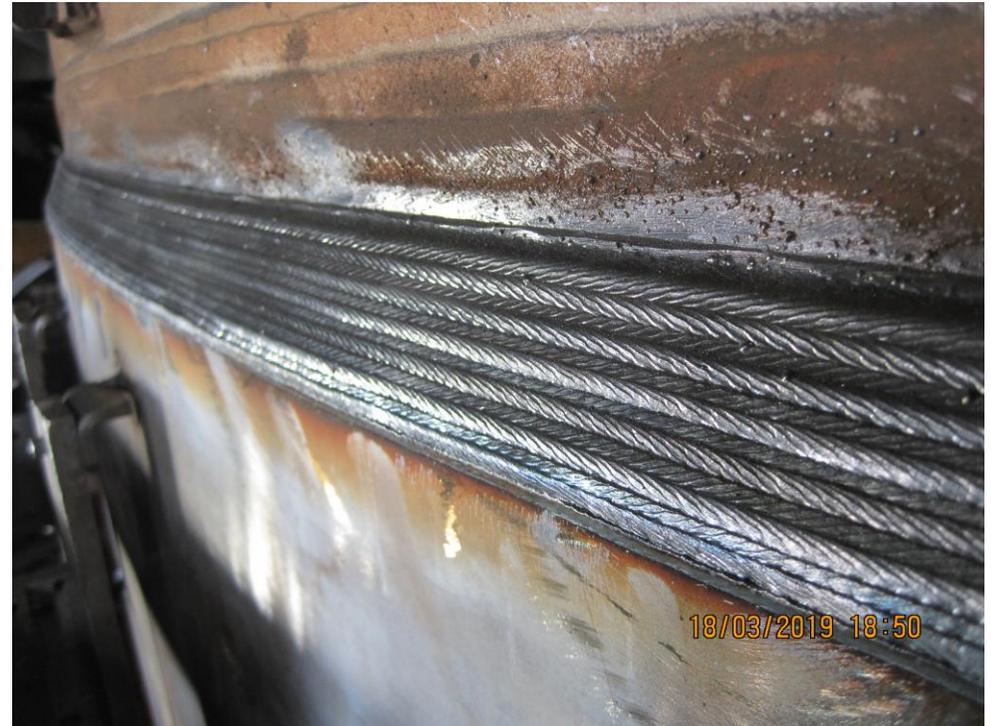
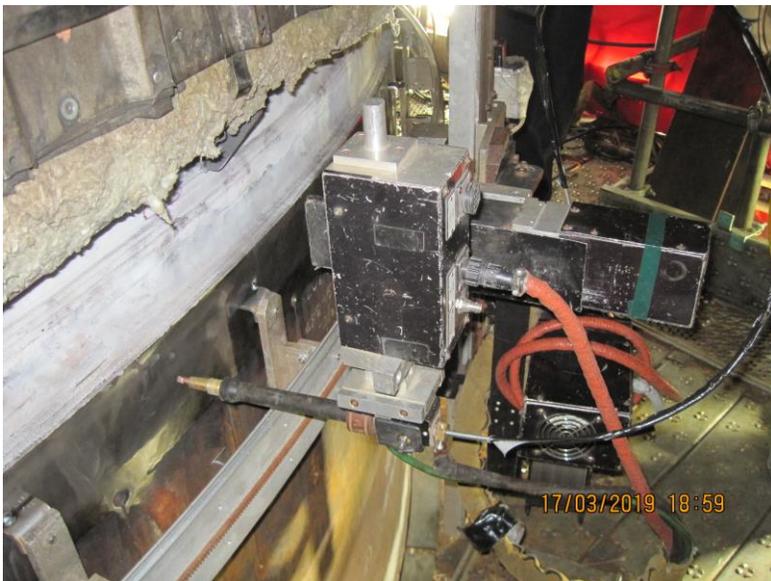
REPAIR SEQUENCE – AUTOMATED MIG WELD

14. TIG (GTAW) weld “tee sections” to approx. 6” down the vertical weld area.
15. Fill and cap attachment weld using automated MIG (GMAW-P).

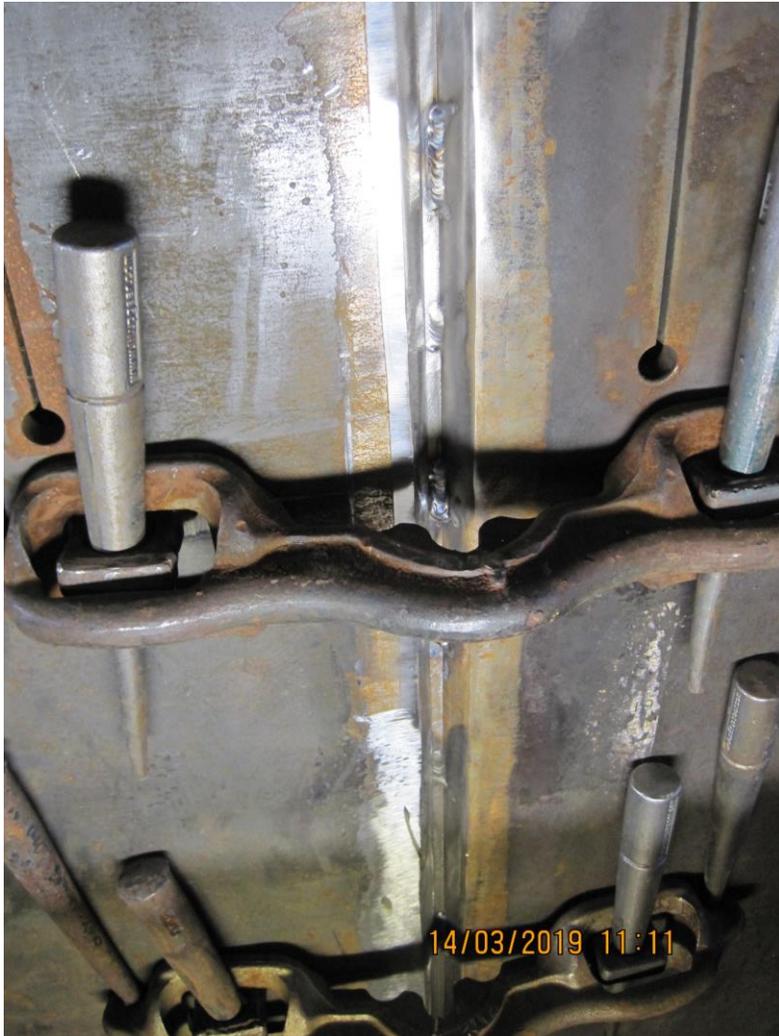
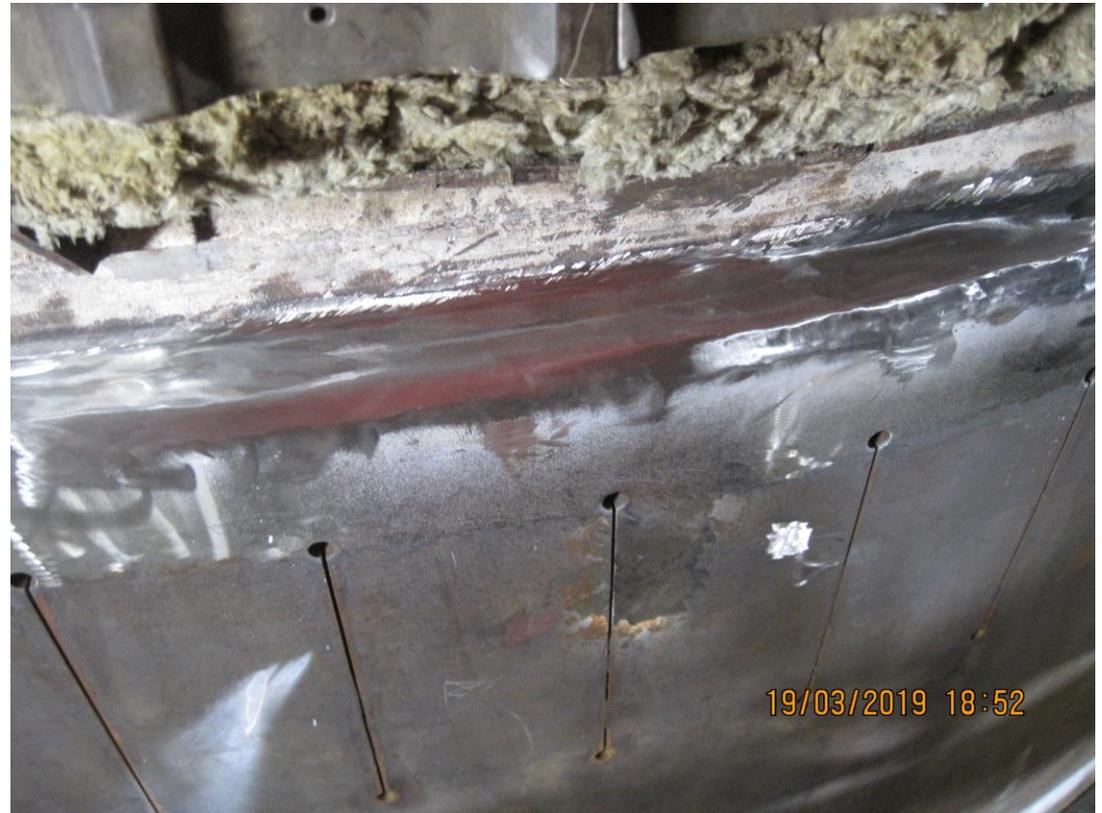
REPAIR SEQUENCE – VERT'S & PROFILING

- 16. Temper-bead MIG (GMAW) weld skirt-vertical welds.
- 17. Grind and polish attachment weld.

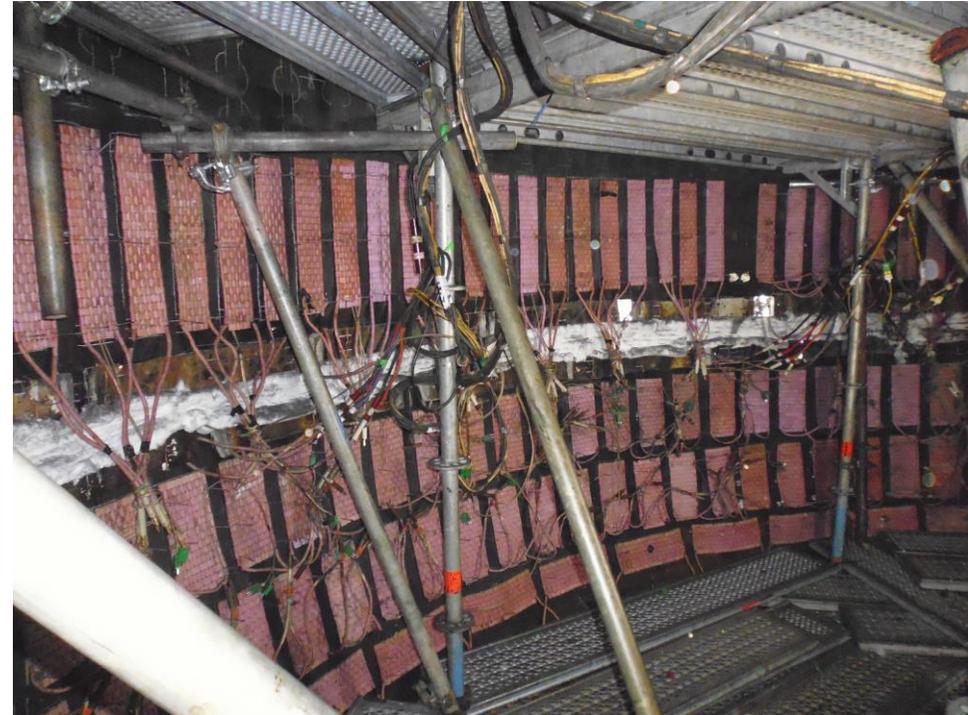
REPAIR SEQUENCE - PWHT

18. MPI all welds.
19. PWHT attachment weld at 690 °C (1275 ° F) for two hours.
20. MPI all welds & PAUT (automated) attachment weld from the inside of drum.
21. PMI all welds
22. Complete QA/QC documentation.

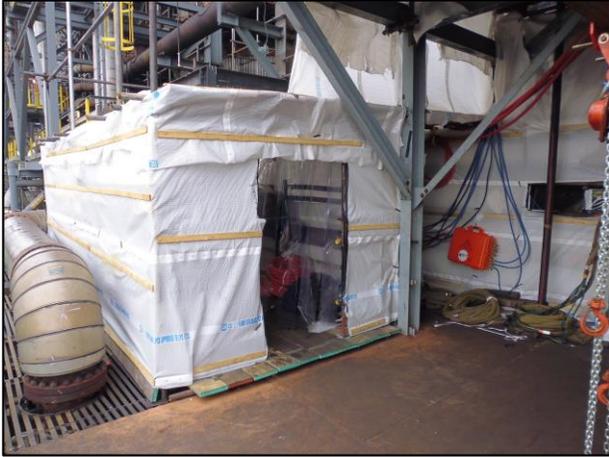
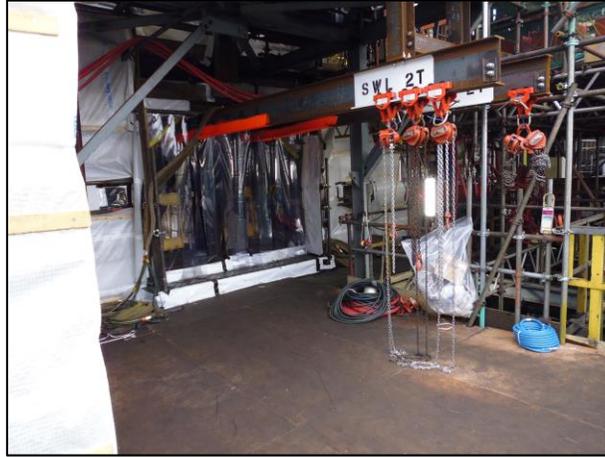
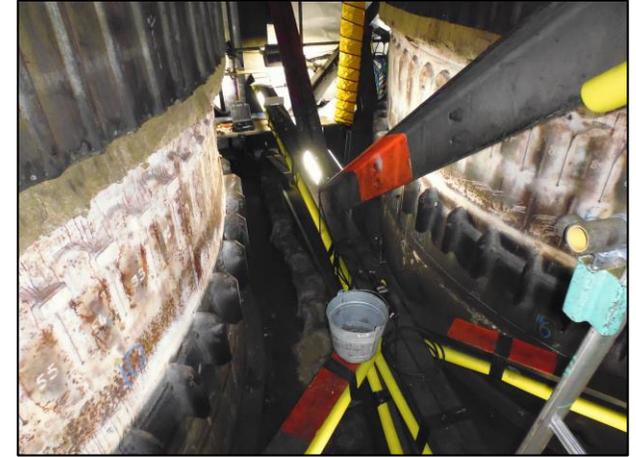
HELP YOUR CONTRACTOR

- Provide clean, enclosed workspace with active ventilation and safe access/egress.
- New skirts were floated in on bespoke “run-way” beams which allowed for precise alignment.
- Temporary “tent” constructed to keep PPE, permits and welding consumables dry.
- Viewing windows installed to monitor progress without having to enter the space where grinding & welding were taking place.
- Scaffold platforms constructed to store PWHT equipment and route cables & air hoses.
- Entire area treated as a “confined space” with 24 hour hole/fire watchers.
- All personnel fitted with 4-way gas monitors.
- Welding contractor used air-fed hoods during grinding, air-arcing and welding activities.
