**PVP2018- 84734**

## **A NON-BOLTED RESTRAINT FOR COKE DRUMS**

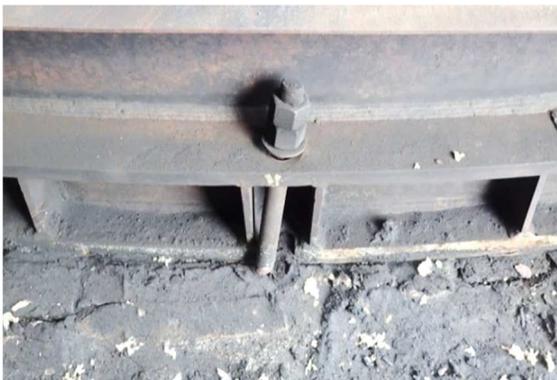
**Figure 2 – Failure of Anchor Bolts**

Considerations for transient thermal loads during start-ups and shutdown, process-induced vibration loads, and impact of cyclic operation are ambiguous and left up to the discretion of the designer. Not properly accounting for these additional loading conditions can result in the failure of anchor bolts (see Figure 2), grout and shim plates (see Figure 3), or the skirt. (see Figure 4)

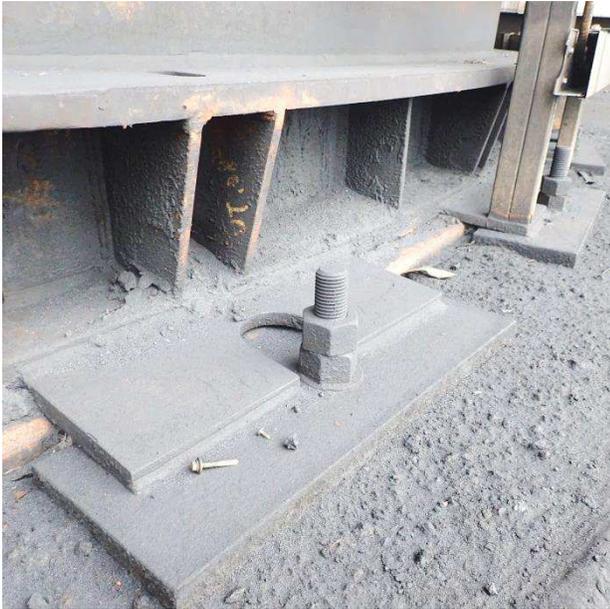
**Figure 5 - Early Version of Sliding Restraint**

To overcome the repeated failures of anchor bolts a sliding restraint plate system was developed. The first variation implemented was a plate system free to slide with only guiding plates. The anchor bolts were removed. This system has performed satisfactorily for four years.

Figure 5 shows an early version of the sliding restraint.

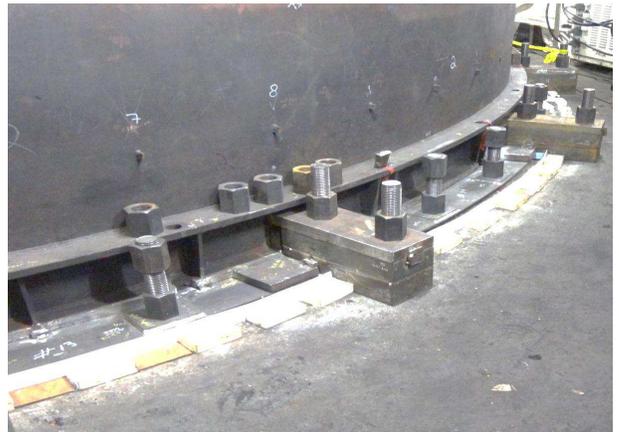
**Figure 7 – Assembly before Final Grout**

The restraint assembly before and after final grout is shown in Figs. 7-8. This system has satisfactorily performed for two years.

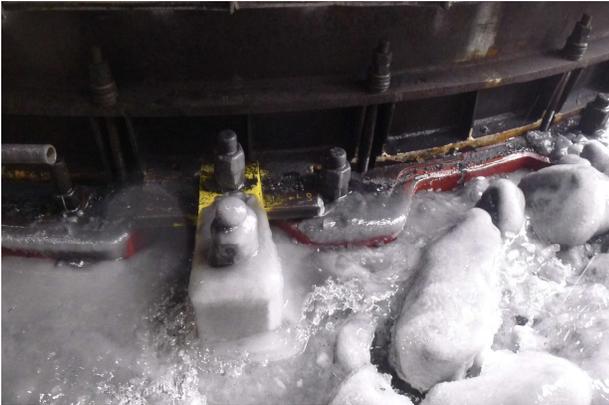
It is important to recognize and mitigate operational and environmental challenges that may negatively impact the effectiveness of these anchors, such as the icing of restraints shown in Figure 9 which was mitigated with steam lancing and ice removal.

Figure 9 – Icing of Restraints
